UVC: Florida Hospital Puts HVAC Maintenance Under A New Light

Florida Hospital has found that high-output ultraviolet-C lights installed in the AHUs reduce or eliminate coil-cleaning programs — yielding ongoing energy savings, a reduction in HVAC system maintenance, and the elimination of cleaning chemicals. The facility also reports IAQ and infection control benefits as the regimen continues.

BY FIROUZ KEIKAVOUSI

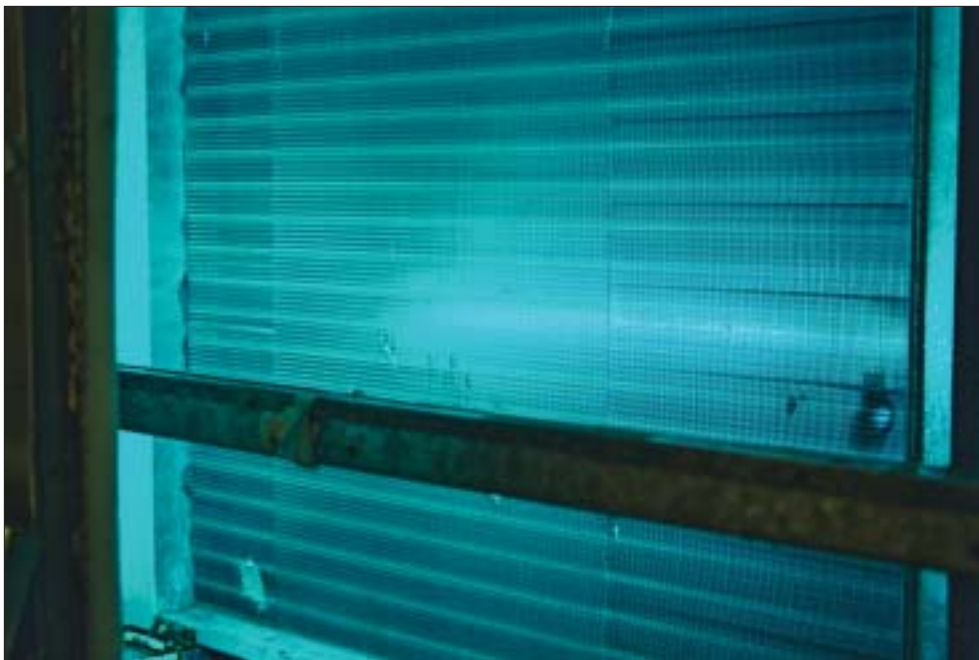
A control unit in one of the early tests, this air handler was later equipped with UVC.

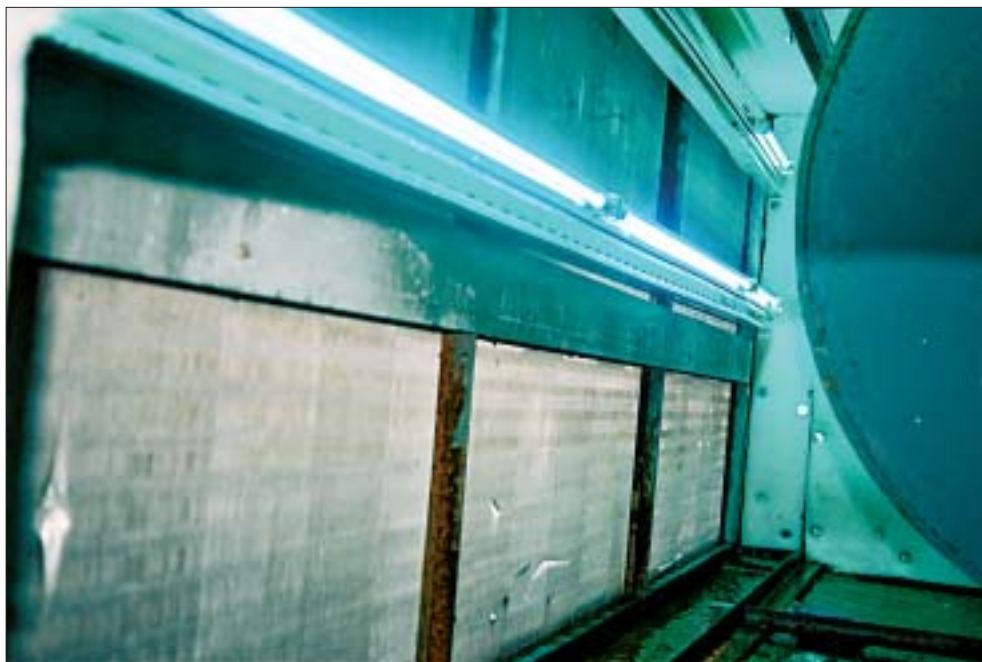
A recent UVC installation with a large coil.

After reviewing these initial results, the hospital administration agreed to expand the use of UVC. By the beginning of 2004, more than 100 AHUs in seven FH campuses were outfitted with the lights (Table 1), as well as some ceiling-mounted and portable air circulating units. To obtain desired results in the AHUs, we generally follow the manufacturer's recommended guideline of 24 in. of UVC tube length for every 4 sq ft of coil face area.

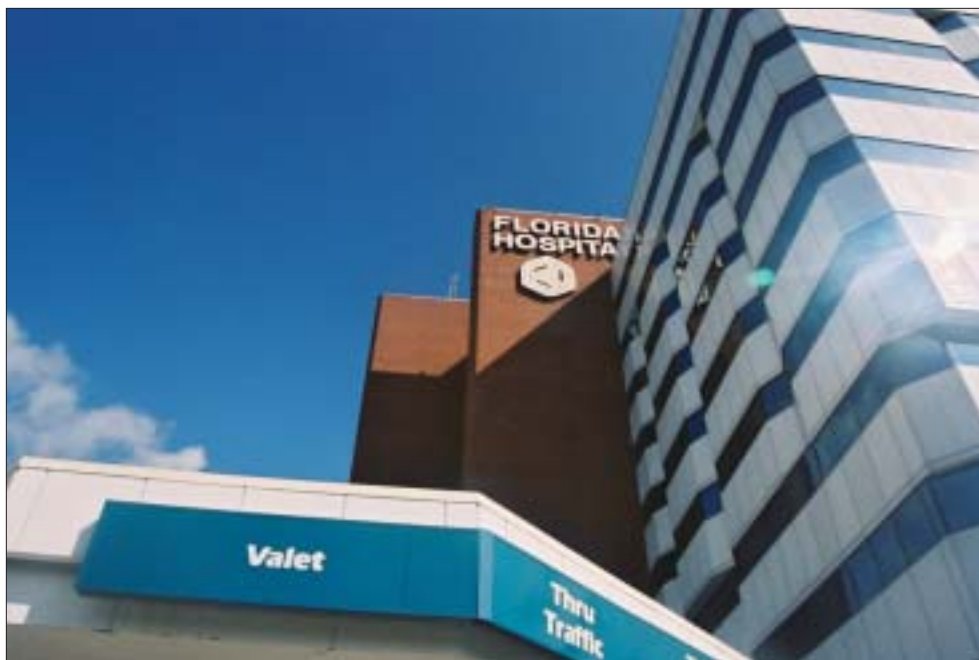
UVC lights have been used in facilities throughout the Florida Hospital system.
